Subject: Firomatic® ½" FPT Fusible Safety Valve p/n 12130

Issue: Consumer Product Safety Alert - Immediate Action Required

Quality Alert Bulletin

October 7, 2016

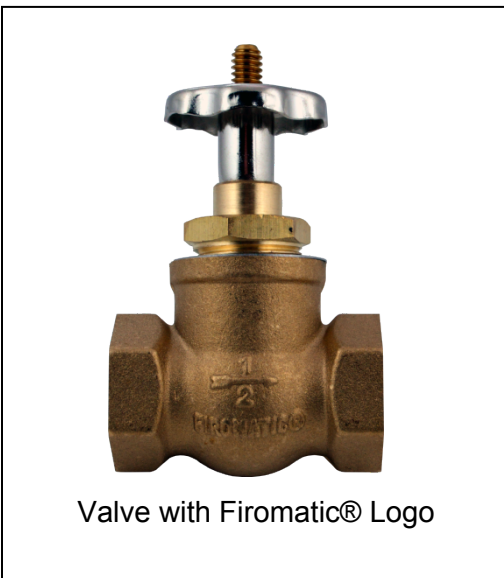
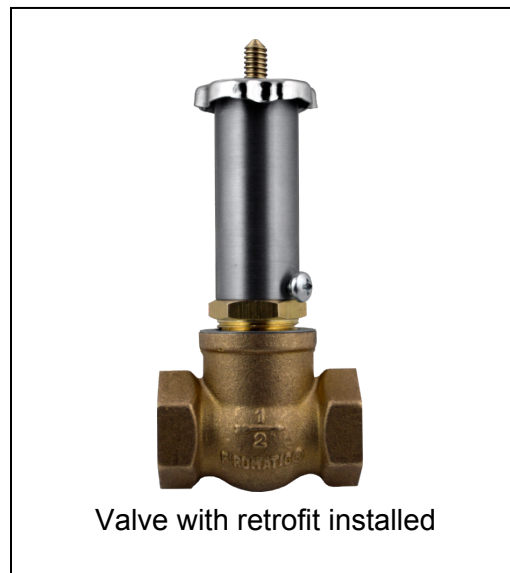
Recently, we became aware of a design deficiency in our ½" 'Firomatic' Fusible Safety Valve part number 12130. This bulletin covers ONLY the ½" FPT version p/n 12130, previous p/n B200F.

Under certain conditions, if the valve is exposed to temperatures exceeding the handle's temperature rating and the valve 'fires' or actuates, the stem may not travel far enough to properly seat the valve and shut off the flow of fuel. This could result in a dangerous situation if there is a ruptured fuel line downstream of the valve. There have been no reports of this situation arising, but the potential for this issue to occur does exist. This does not affect the valve's operation when used as a manual shut off valve.

Only 'Firomatic' versions of this valve are affected. A picture of the affected valve is shown above. ONLY those valves with the name cast into the valve body need attention.

Please immediately begin identifying suspect valves in service for retrofit. Retrofit kit part number 12130VR will be available from any Beckett Distributor or by contacting our Customer Service Department. A \$ 50.00 Labor Allowance will be paid for each valve retrofitted. Instructions for adding the kit to installed valves are included with the kit. Estimated completion time to perform retrofit is less than 10 minutes.

To retrofit an existing valve, approximately 3-1/2" of clearance above the top of the valve stem will be required. If there is not enough clearance to proceed with the retrofit, the valve will have to be replaced or an additional valve will need to be installed downstream. Availability of replacement valves is pending, please refer to page 1. Along with credit for the valve, a \$ 125.00 Labor Allowance will be paid for each valve replaced.
